CCNY Marshak Science Building

Ahuja Partnership Architects

One of the university's largest buildings finds new life with a steel-reinforced re-skinning of its deteriorating concrete facade.

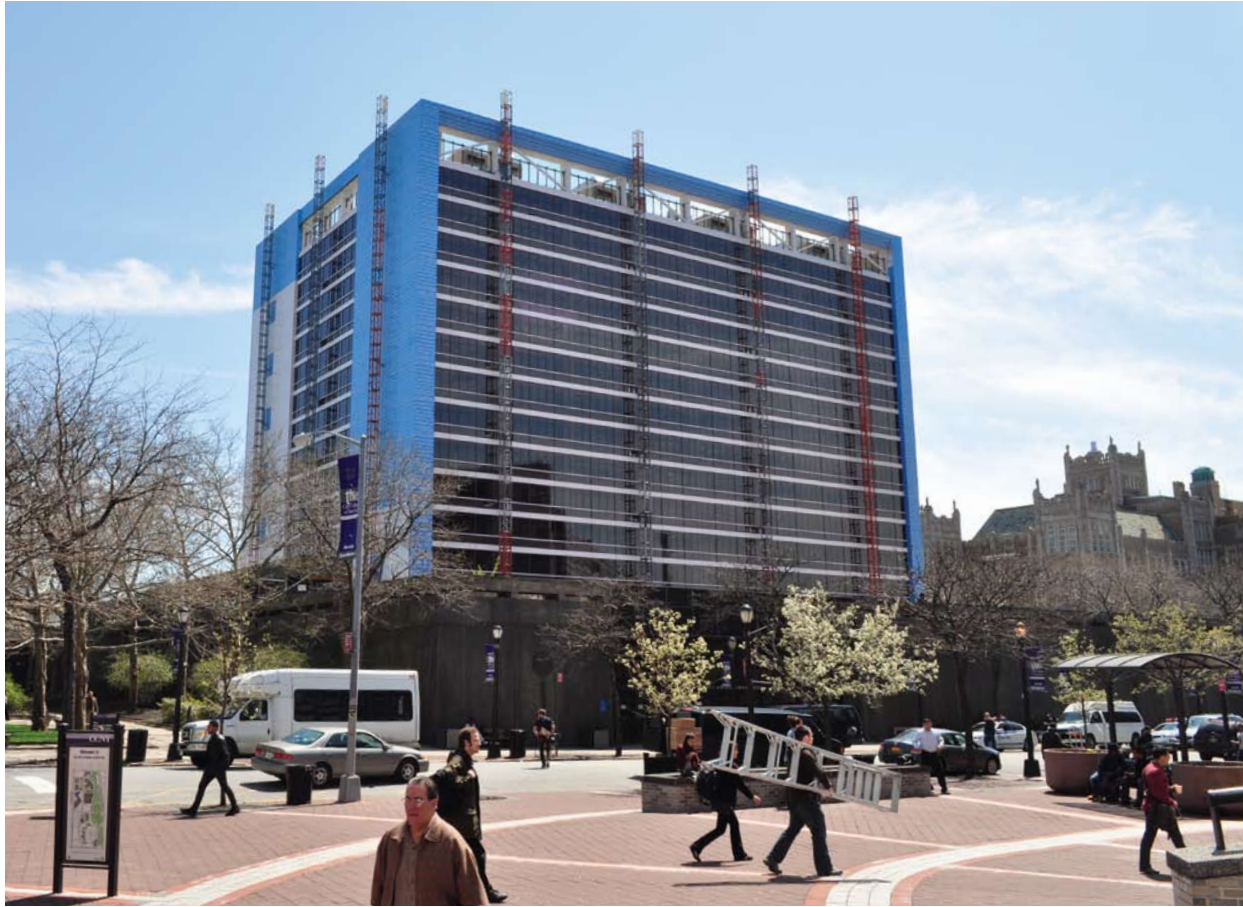
Above Recladding the Marshak building will increase its energy efficiency and prevent further deterioration of its 40-year-old lightweight concrete facade.

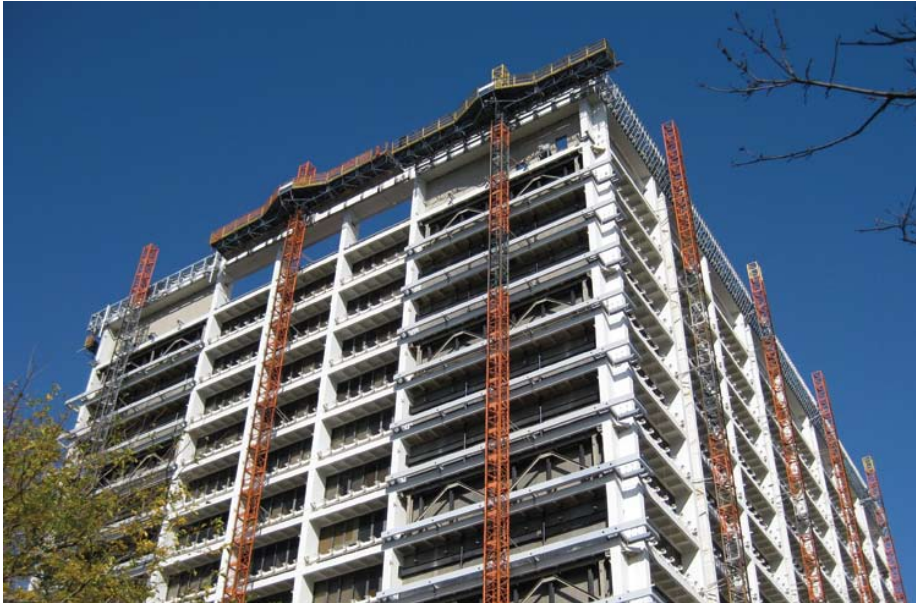
Above HSS box sections spanning between columns will transfer the curtain wall load directly to the existing columns without transferring any new load to the slab edges.

Execution of APA's proposed design presented some challenges, as testing had established that the concrete deterioration was so extensive at the exterior slabs that the building's new curtain wall could not be supported on the slab edges. Instead, 8-by-8-inch HSS box sections were installed spanning between columns, which were designed to transfer the load

of the curtain wall directly to the existing columns without transferring any new load to the slab edges.

The box sections also fulfill the function of bracing the existing concrete columns. They are connected to each column by means of 24-inch-square by 5/8-inch-thick end plates sized to achieve high fixity, thereby reducing deflections and economizing on HSS size. Controlling deflections was critical in ensuring serviceability of the curtain wall. Plates on opposite sides of the columns are bolted together with high-strength, corrosion-resistant A588 through-bolts torqued to 130 foot-pounds. Locations for the through-bolting were first established by pachometer to minimize cutting the column reinforcement.

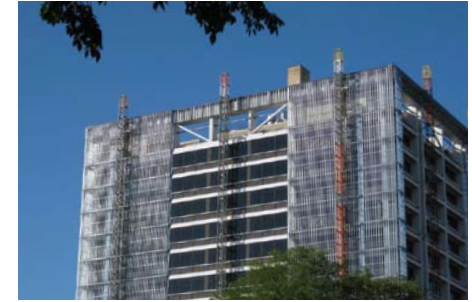
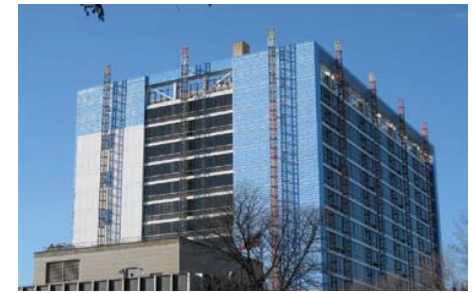
Above Existing solid wall sections at the four corners of the north and south elevations will be clad in aluminum panels.

Along the north and south elevations, the existing solid wall sections at the four corners of the building are designed to be clad in aluminum panels, which continue horizontally

at the roof level to create a portal-like expression along the east and west facades. As of June 2011, construction was largely complete, with most work carried out while the science center's computer, medical, and laser labs, in addition to more than two hundred teaching and research labs, remained fully operational.
